INNOVATIVE ASSESSMENT ANALYTICAL RESULTS REPORT

Lower Silver Creek

Summit County, Utah

UTAH DEPARTMENT OF ENVIRONMENTAL QUALITY
Division of Environmental Response and Remediation
Prepared by : Ann M. Tillia

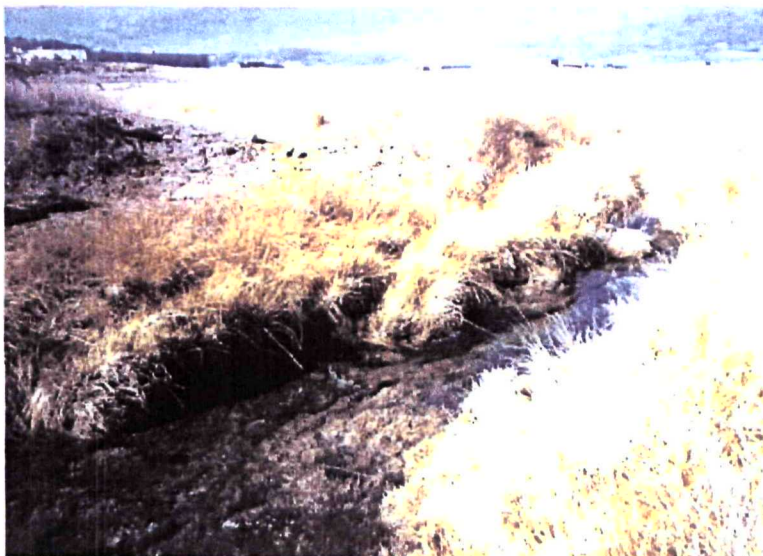
Photo: 3-25. Date: 11/09/01. Sample: XRF145.
View: to the NW and sample site on a mound shown on the left of photo. Silver Creek is in the foreground, and the Sheriff's facility is in the background and to the left.

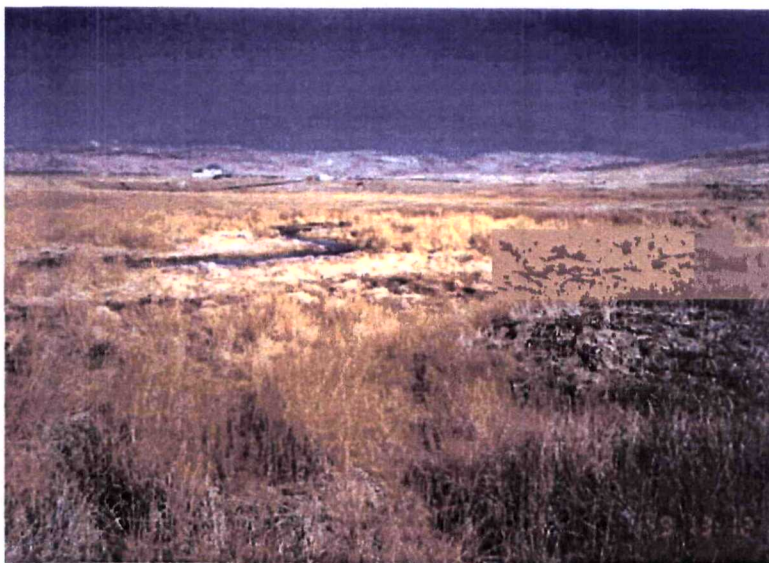
Photo: 4-2. Date: 11/09/01. Sample: XRF147.
View: to NE with the Pace farm building in the background. The sample site was on the mound on the right side of the photo. In the center of the photo is Silver Creek and a saturated hummocky grassy area between the creek and the mound.

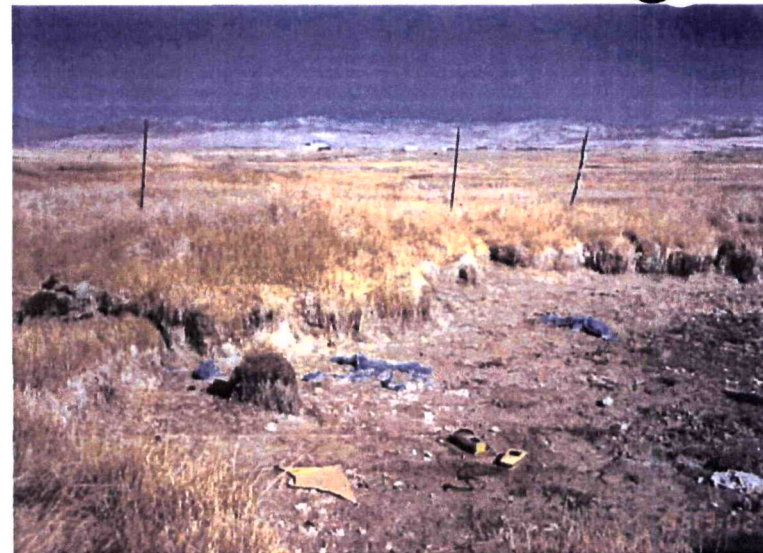
Photo: 4-1. Date: 11/09/01. Samples: XRF146.
View: to the NE and the sample site within a depressional area east of the Sheriff's facility.

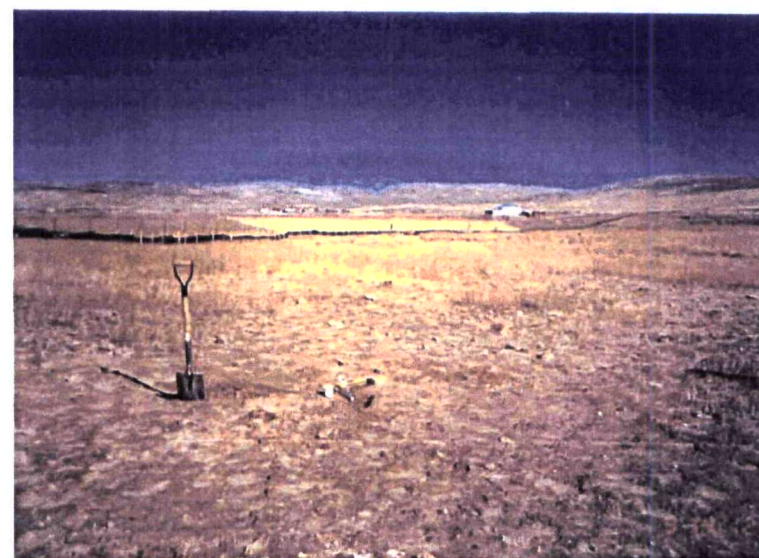
Photo: 4-3. Date: 11/09/01. Sample: XRF153 and SS-63.
View: to the NE with the sandy, grassless sample site in the foreground and Promontory Road in the background.

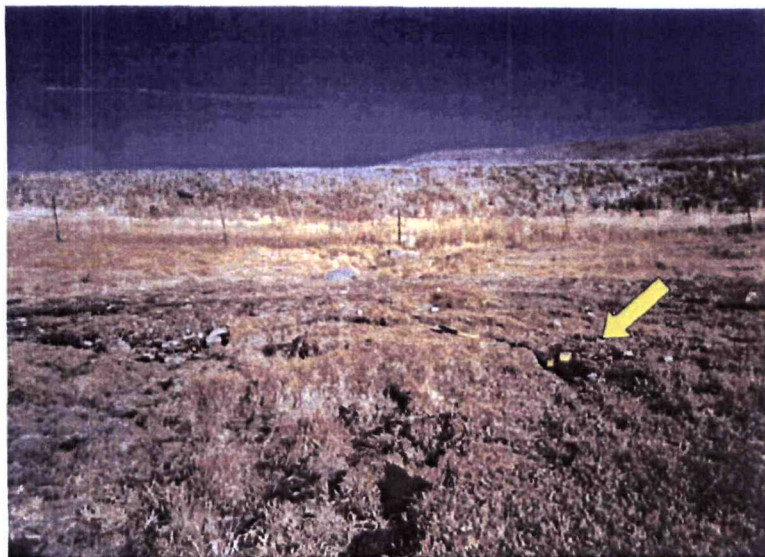
Photo: 4-4. Date: 11/09/01. Sample: XRF164 and SS-64.
View: to the east with the Rail Trail on the embankment in the background, a shallow ditch and partially buried culvert to the left, and the sample site to the right on the upland. The arrow indicates the sample site.

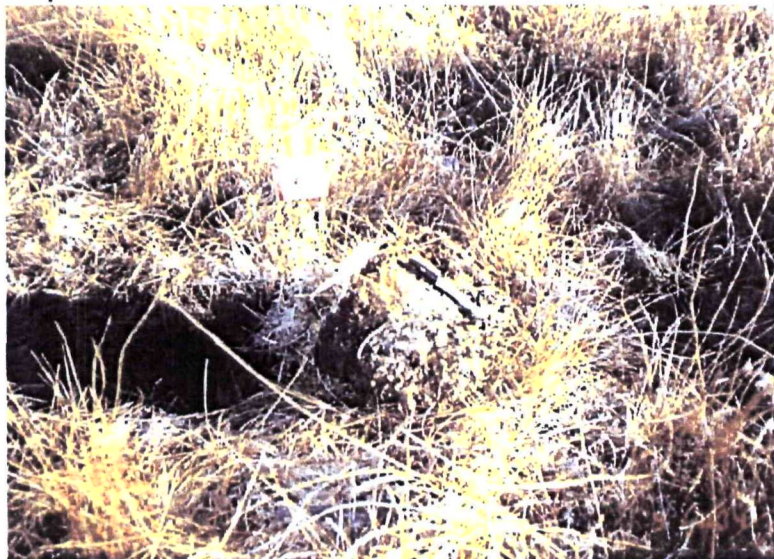
Photo 4-6. Date: 11/09/01.
View: an existing hole flagged "SC-23" located near the XRF166 site.

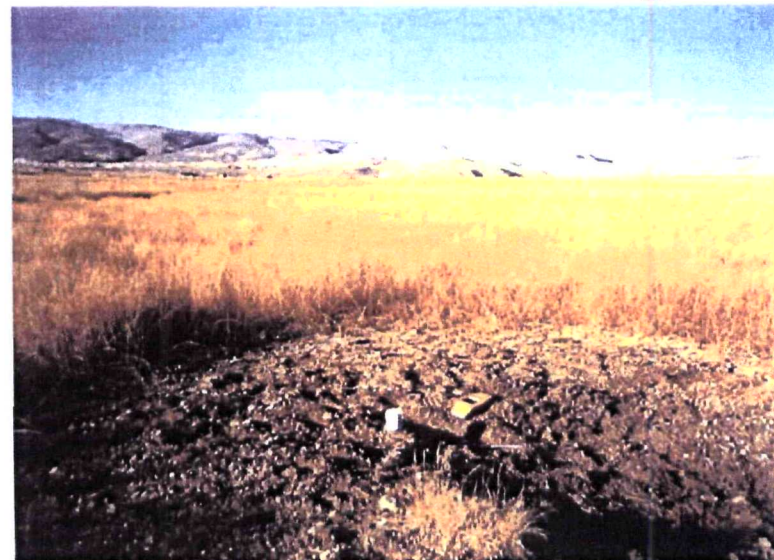
Photo: 4-5. Date: 11/09/01. Sample: XRF166 and SS-65.
View: to the north of the sandy and grassless sample site, which is surrounded by tall wire grass.

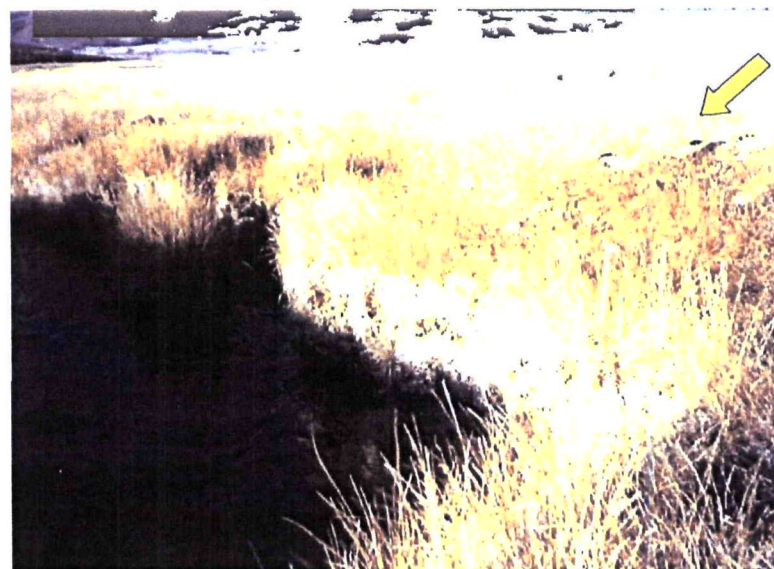
Photo: 4-7. Date: 11/09/01. Sample: XRF167.
View: to the NW with the sample site on the east bank of Silver Creek. At this site Silver Creek (in the shadow area of the photo) is entrenched approximately three feet. The sample site is approximately 30 feet north of a fence line (no GPS data).

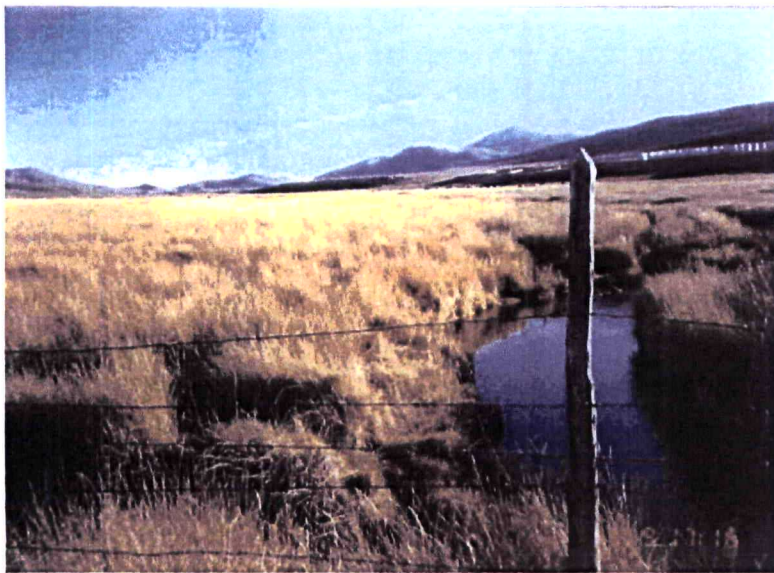
Photo: 4-8. Date: 11/09/01.

View: to the south of sample site XRF167 (Photo 4-7). At this site Silver Creek is wide and deep, and the grass is tall. The area beyond the fence was not sampled (F. Gilmore property).

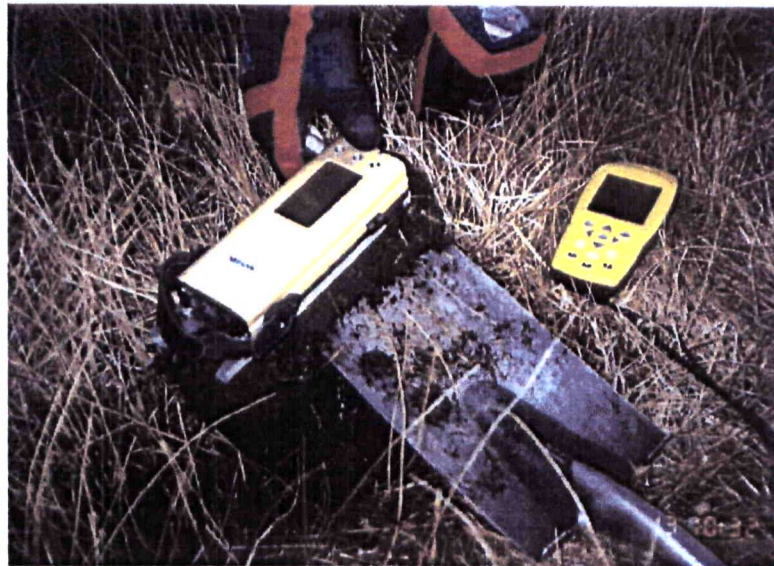
Photo: 4-10. Date: 11/13/01. Sample: XRF 170.

View: close up of sample site. Sample was taken from the bottom side of a wire grass clump (sample depth is 3 inches).

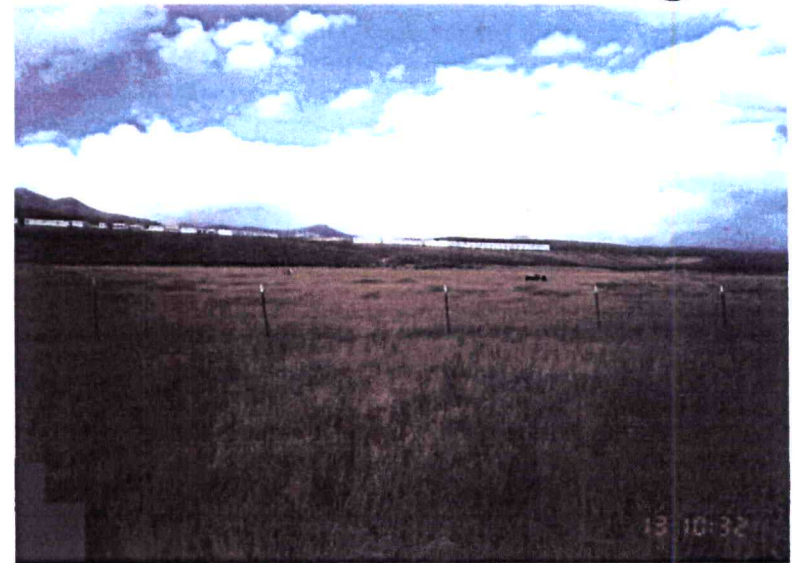
Photo: 4-9. Date: 11/13/01.

View: an overview of the sample site (XRF170) to the NW. The sample site is within tall wire grass, as shown in Photo 4-10. In the right-center of the photo are cattle (the small dark spots).

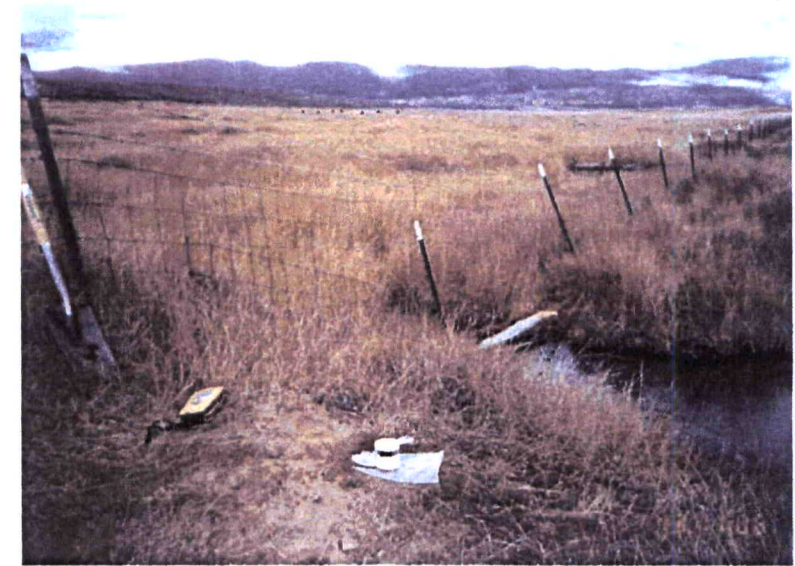
Photo: 4-11. Date: 11/13/01. Sample: XRF173 and SS-66.

View: to the NW of sample site and adjacent water hole. The soil is sandy and surrounded by wire grass. Beyond the fence, cattle are the small dark spots in the center of the photo.

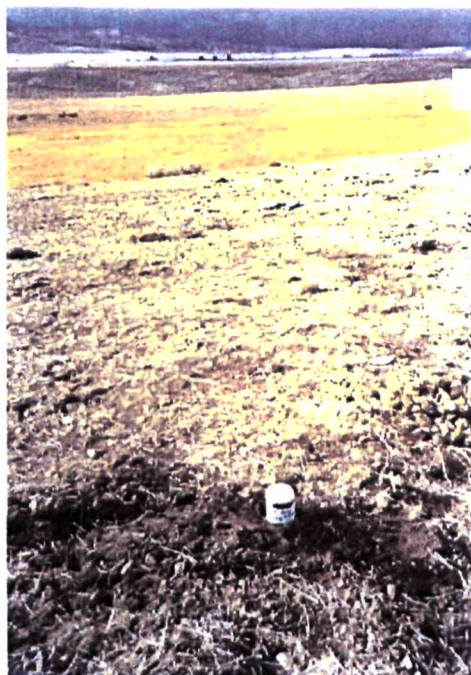
Photo: 4-12. Date: 11/13/01.
Sample: XRF190 and SS-67.
View: to the W-NW with the Olympic trailers in the background. The sample site is on higher ground on the east side of the meadow (adjacent to the Rail Trail). The sample site area is on gravelly soil and cattle-grazed grass. Cattle are down in the meadow in the upper left side of the photo.

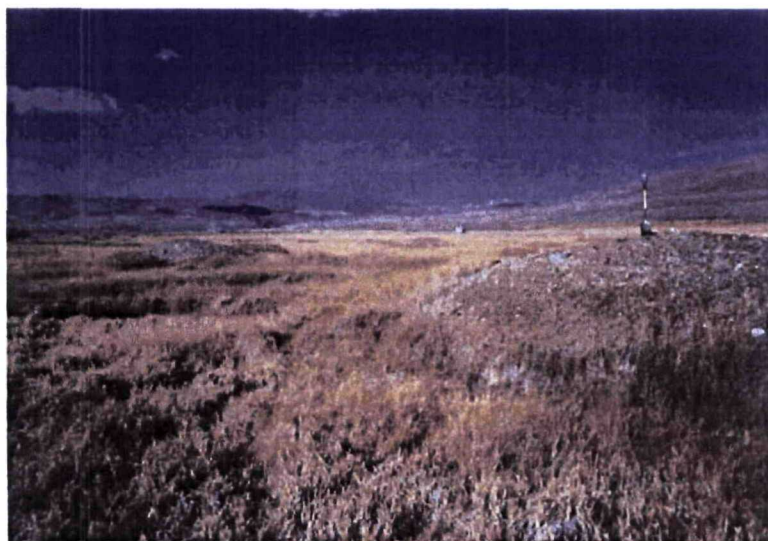
Photo 4-14. Date: 11/13/01. Sample: XRF201 and SS-68.
View: to the north, the samples were taken from the largest mound in the area.

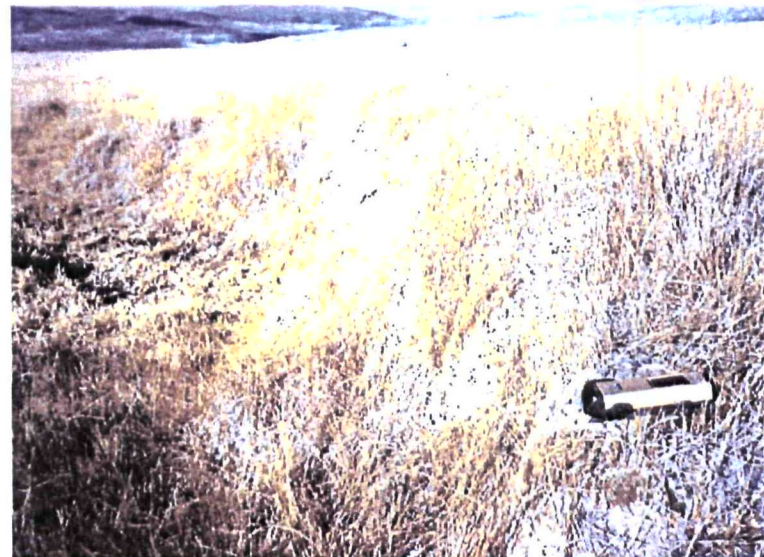
Photo: 4-13. Date: 11/13/01. Sample: XRF195.
View: to the north of the sample site on the located on the west side of a dry channel, the surrounding area is wire grass, but the lowest point in the channel is moist and the grass is not wire grass. The channel is approximately 3 feet lower than the surrounding area.

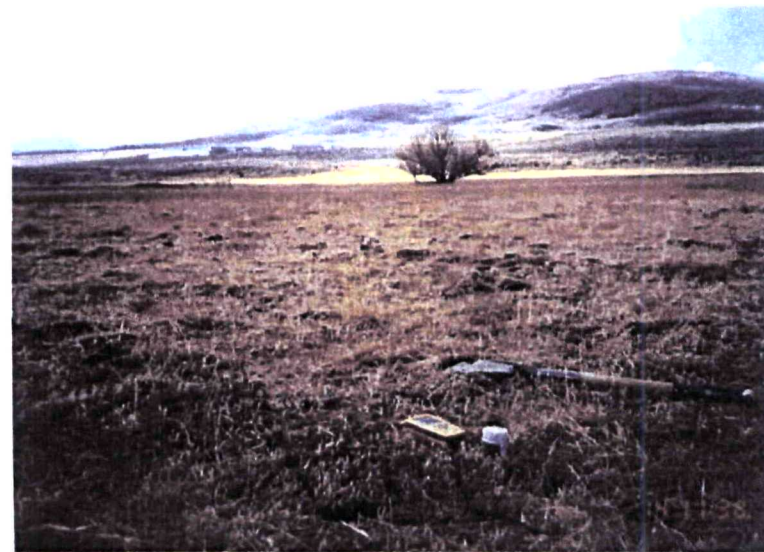
Phtoo: 4-15. Date: 11/14/01. Sample: XRF211 and SS-69.
View: to SW, sample site is on the east side of the meadow, the sample was taken from the flip side of an overturned grass clump at a depth of six inches.

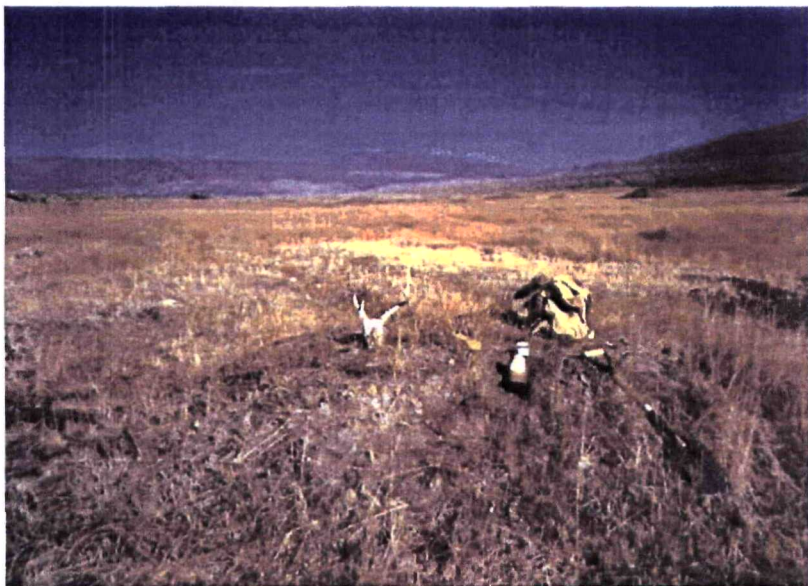
Photo: 4-16. Date: 11/015/01. Sample: XRF256 and SS-73.
View: to the north, sample was collected from mound in the southern portion.

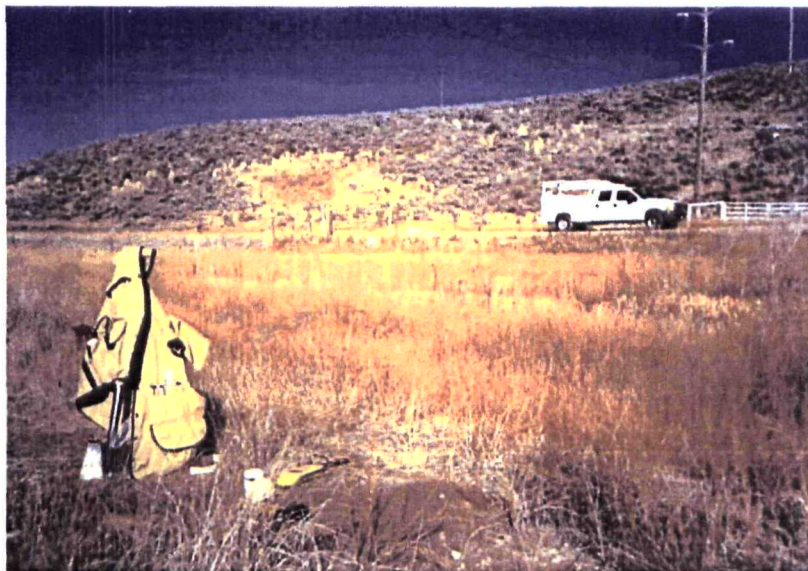
Photo: 4-17. Date: 11/15/01. Sample: XRF271 and SS-74.
View: of the sample site in a sandy grassless site surrounded by wire grass located between the Geneva plant and the Rail Trail (the sampling truck is on the Rail Trail).

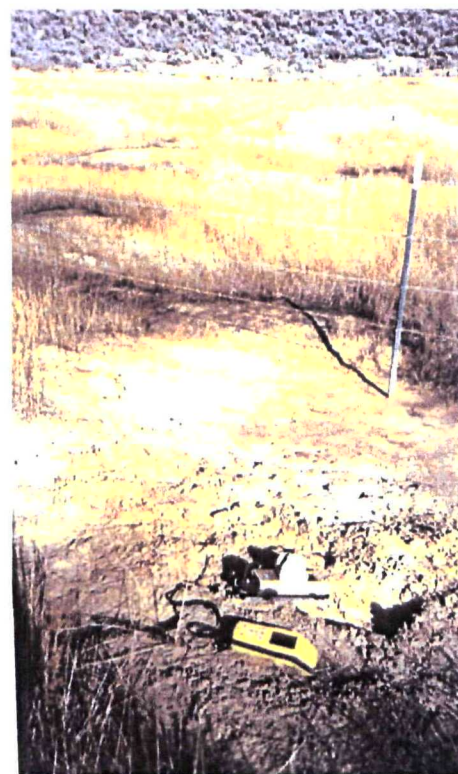
Photo 4-18. Date: 11/15/01.
Sample: XRF275.
View: to SE with the Rail Trail behind the photographer and highway U-248 to the right of the photo.
